Service Report for Rotary Orienter BD 1800-6-8-??

Date: Jan 22, 2009

Prepared by: OnTrack Service Technician

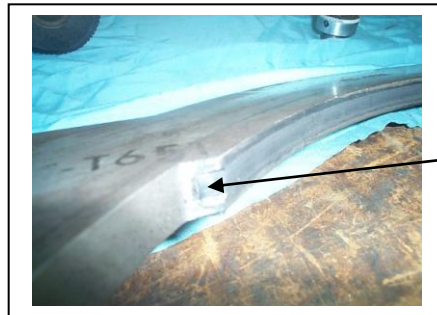
- a) Lower Main Turret assembly found to be in good working order with one (1) exception, Bottle Clamping CAM is worn at entrance of trigger valve actuation. Wear was found from entrance to release point.

Entrance wear area,
continues to end of CAM

- a) Recommended replacement of Bottle Clamping CAM, if not replaced machine will still run but at risk of destroying trigger valves and machine failure.

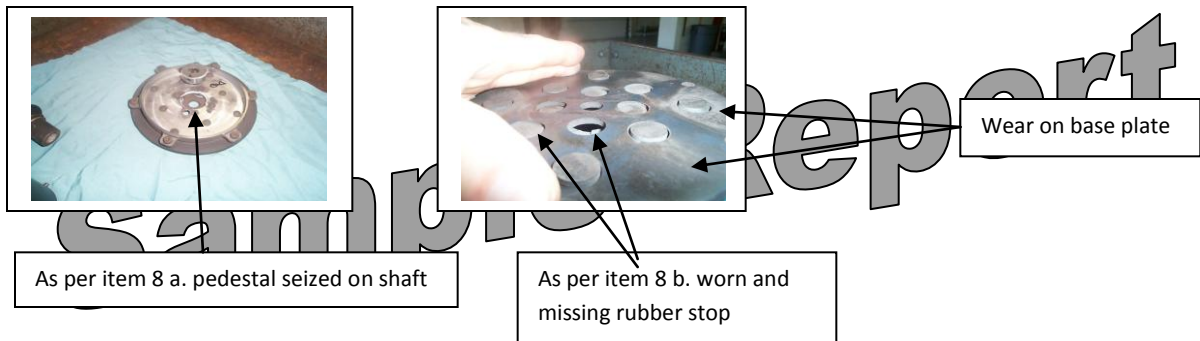
- Bottle Pedestals 1, 5, 7 & 8 – centre hubs seized on actuator shaft.
- Bottle Pedestals 2, 3, 4 & 6 – missing rubber stops, base plate worn,
- Rotary Actuators in good condition.

- Replace 1, 5, 7 & 8 Bottle Pedestals, new model will incorporate new design change as per Orienter 1, provides longer life and durability.
- Replace 2, 3, 4 & 6 Bottle Pedestals, new model will incorporate new design change as per Orienter 1, provides longer life and durability.
- No action required.

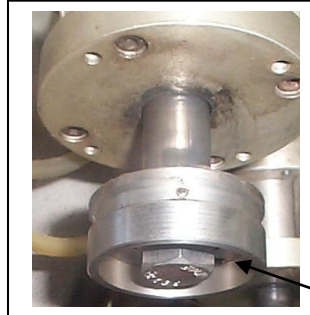
- Bottle Centering Bells badly worn on outer edge and centre position. Also does not comply with required package sizes as per Orienter 1
- Bearing Assembly number 1, 2,3,4,6 & 7 are worn and are at end of service life, machine can run but will cause bottling handling to be sloppy or misaligned.
- Bearing Assembly number 5 & 8 are showing minor wear and are fine, however if action is taken on 9.b. above then these should also be replaced.

As per item 9 b and c bearing assembly

- a. Replace all 8 Bottle Centering Bells.
- b. Replace ASAP (no later than 1 year) Bearing Assembly number 1, 2,3,4,6 & 7
- c. Replace Bearing Assembly 5 & 8 when Bearing Assembly number 1, 2,3,4,6 & 7 are replaced.

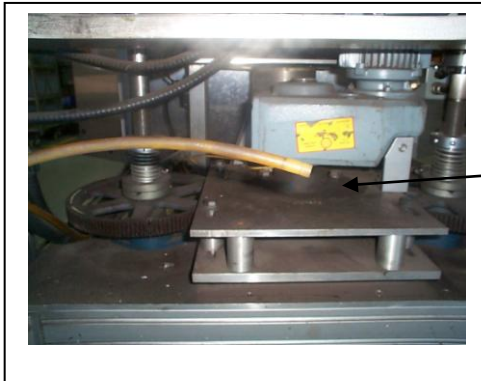
Note: Main air control unit is missing; see safety audit report below for further details.

Air Control and Dump Valve is missing, was part of the original unit as I-O switch is present in panel. Required for safety and control.
